ELECTRICAL ENGINEERING SOLUTIONS FOR HIGH VOLTAGE NETWORKS

CONTRACT:	TPPS-09
SCOPE OF WORK:	Substation Compound Refurbishment
END CLIENT:	Centrica KPS Ltd
LOCATION:	Killingholme, Immingham
DURATION:	18 weeks
VALUE:	£ 316,500 GBP

SUMMARY:

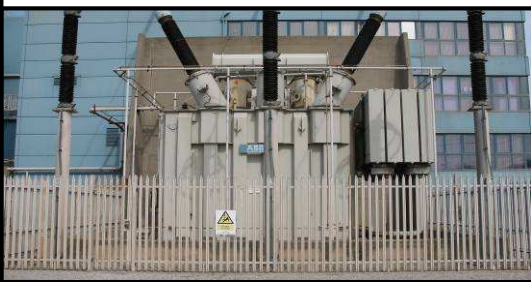
The motor drive mechanism kiosks needed replacing on three of the units due to degraded housings, seals and hinges from almost 20 years exposure to the coastal elements. The BUE type cabinets were procured directly from ABB with a lead time of 8 weeks; meaning the works had to be completed in the second outage. To change the unit's engineers had to remove the drive shaft feeding into the kiosk and the drive mechanism itself to replace the cabinet. Once replaced, the mechanism was re-assembled within the cabinet, drive shaft installed and the unit fully commissioned for operation.

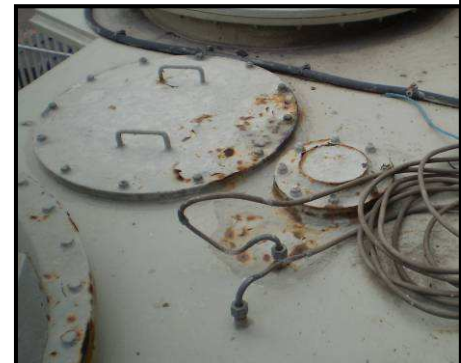
The worst affected by the elements was the Steam Turbine Generator Transformer. Being more exposed to the elements and having no protection from other buildings had allowed significant degradation of the main tank lid and high voltage turrets. Thickness testing identified that almost half of the material had been weathered away in some places, and unlike other components simple fabrication and replacement was not an option. All areas were cleaned using grinding equipment to AS 2.5 standards and primer paint applied, with the worst areas having 10 mm steel plates secured over the top with double fillet welds on all sides, before a the final dual coat paint system was applied. TPPS also designed and implemented a method of sealing oil leaking from the studs securing the HV bushings to the turrets using 'encapsulated sealing nuts' with O-rings rather than the timely and expensive solution of dismantling to replace gaskets.
