ELECTRICAL ENGINEERING SOLUTIONS FOR HIGH VOLTAGE NETWORKS

CONTRACT: TPPS-15
 SCOPE OF WORK: Dismantle of Generator Transformer
 END CLIENT: E-on
 CONTRACTOR: Alstom Power Ltd
 LOCATION: Isle of Grain Power Station, Kent
 DURATION: 5 weeks
 VALUE: £ 220,400 GBP

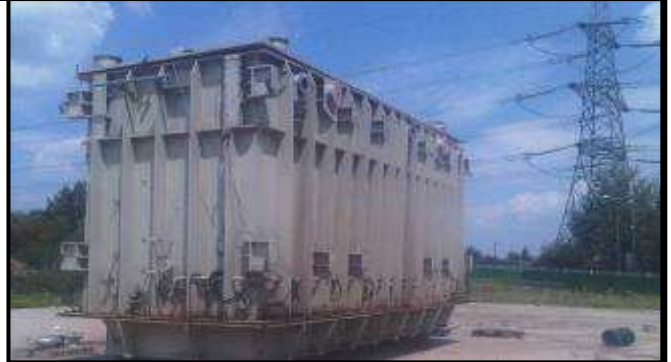
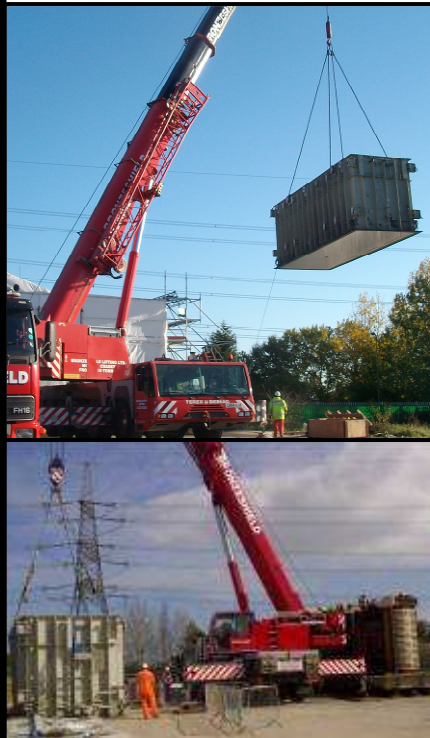
TPPS was successful in our tender to remove and dispose of a failed 515MVA OFAF Generator Step-Up Transformer at Isle of Grain Power Station, Kent. The transformer suffered a major fault in August 2010, and the fully assembled 418 tonne unit had 90 tonnes of mineral oil and 50 tonnes of ancillary equipment removed, and main tank moved to a storage area on site awaiting fault analysis and warranty discussions. Before the five week programme commenced in March 2012, TPPS Ltd had to identify and implement safe working practices to include health & safety control measures for working with heavy plant and equipment, environmental hazards such as the transport and disposal of oil impregnated materials both on and off site and provide evidence that items would be disposed of responsibly.

Weighing 276 tonne on its own, the main transformer tank held a five limb steel core and clamp assembly which secured the three sets of LV, HV and HV tapping windings. The legal restrictions associated with transporting such a vast mass coupled with our in depth knowledge of transformer design supported our decision to dismantle the main tank into its components parts at site. Cranes were used to lift large sections and load onto heavy haulage vehicles for transport to audited waste contractors; however sections such as the tank housing and base, weighing 45 tonnes, had to be cut into manageable sections before loading. Around 50 tonnes of ancillary equipment, which included 44 cooling radiators, 22 fans, HV and LV turrets, marshalling and control kiosks, were loaded and transported for refurbishment or disposal. Operational equipment such as the OLTC drive mechanism, cooling pumps, and monitoring equipment were tested and refurbished for sale as strategic spares on similar units at other UK power stations.

The main transformer tank measured 11 metres long, 4 metres wide and 4.5 metres high; with the first task to remove the lid and outer shell and expose the 228 tonne core, clamp and winding assembly. The assembly consisted of five upright steel core limbs between upper and lower yolks, three sets of windings each consisting of three coils; LV, HV body and HV tapping coil, located on the central three limbs and secured with insulation and large core clamps.

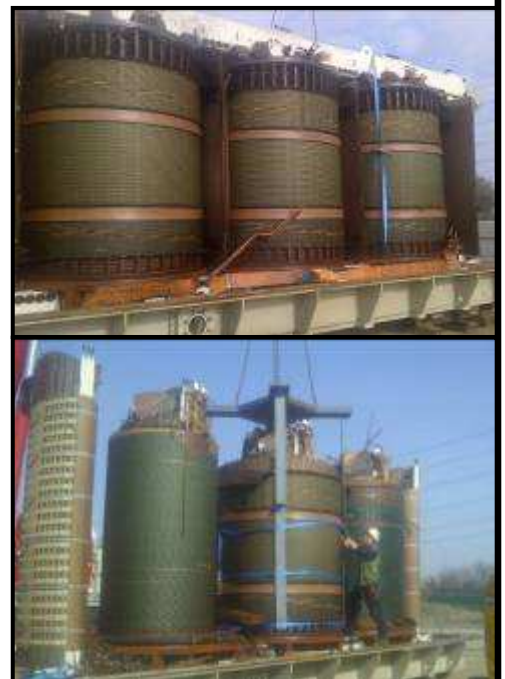
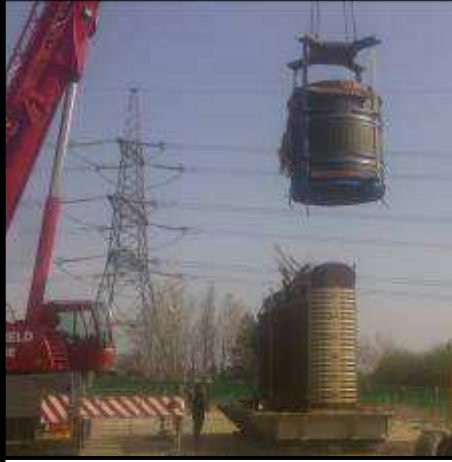
The only item within the core and winding assembly being partially re-used was the core steel; however the core steel is the main chassis of the assembly and weighed 154 tonnes on its own. The core clamps were unbolted and lifted off by the crane, and dismantle of 23 tonne upper yolk begun.

With the upper yolk dismantled the packing insulation between the core clamps and windings could also be removed which would then allow each winding to be lifted over its core limb, and the remainder of the core dismantled in sections. Approximately 325 tonnes of material would be dismantled and removed from the site in 14 different stages with the aid of mobile crane, excavator with grabber, telehandler, specialist winching vehicles, mobile elevated working platform equipment and numerous large recycling skips.

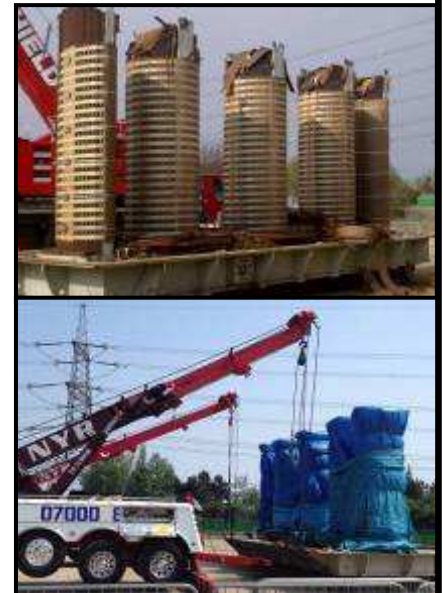
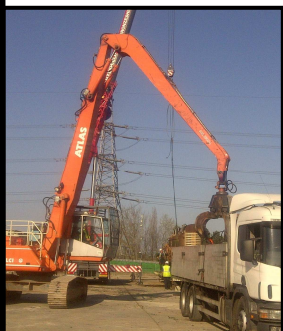
With each of the windings removed the five upright limbs and lower yolk could be removed, the safest way being to overturn the base and remaining core over onto its side under controlled conditions. Before this operation could be completed mineral oil that had wept from the core and winding assembly during dismantle and collected in the base had to be pumped into barrels and any residues removed to ensure the land was not contaminated.

The 130 tonne core assembly was lowered onto its side using two 75 tonne specialist winching vehicles and once laying on it's side each of the three winding limbs, weighing 27.3 tonne each, and the two outer limbs weighing 13 tonne each, were removed from the lower yolk and loaded into shipping containers for removal from site along with the upper and lower yolks weighing 23 tonnes each.

All that remained of the 276 tonnes tank now was the 12 tonne base which was cut into smaller sections and transported to the nominated contractor for recycling. With the unit now completely dismantled the site had to be cleared of 8 tonnes of waste such as timber supports, pallets and general waste so that the site could be inspected, handed back to the owner and TPPS demobilise from site.
