ELECTRICAL ENGINEERING SOLUTIONS FOR HIGH VOLTAGE NETWORKS

CONTRACT:	TPPS-11
SCOPE OF WORK:	Failure Analysis & Transformer Supply
END CLIENT:	Pahlawan Power Sdn Bhd
LOCATION:	UK based services
DURATION:	9 weeks
VALUE:	£ 1,031,000 GBP

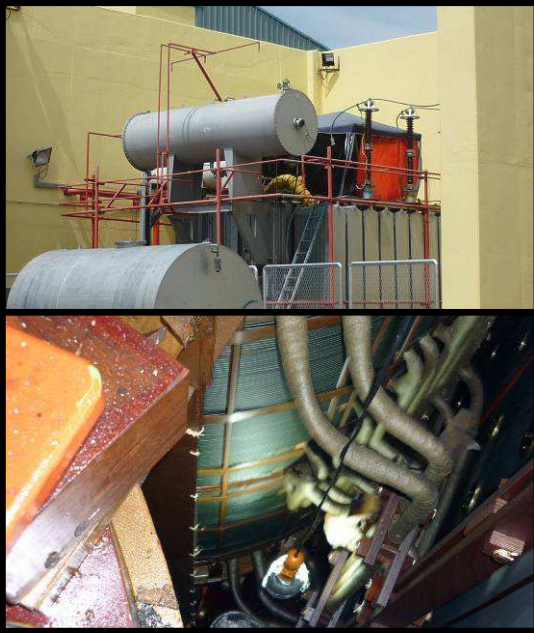
TPPS Ltd's Technical Services Manager and Senior Test Engineer flew to Malaysia at the earliest opportunity to complete physical studies, tests and inspections and analyse any data given by the client from other sources. The stresses caused by the fault had been so severe that the side walls had deformed and separated from the stiffening beams at the bottom of the tank, the HV bushings of the 'B' and 'C' phases, and the surge arrester bushing on the 'A' phase had been broken by the internal forces when the fault occurred. Engineers reviewed data from a series of tests completed on the unit, including Turns Ratio & Winding Resistance, Voltage Ratio & Magnetising Current, Insulation Resistance, Frequency Response Analysis (FRA), On Load Tap Changer tap selector tests and Dissolved Gas Analysis of oil samples. The review of all data surmised that an internal discharge had occurred due to an insulation fault between 2 of the windings and subsequently caused arcing with enough force to deform the main transformer tank. Once the initial diagnosis had been given it was clear that any replacement or rewind option from the OEM under warranty would take too long, and the loss adjusters and insurers requested TPPS Ltd use its industry contacts to source a replacement unit that could be sourced and procured sooner. A detailed investigation report was issued to the client to be used for insurance and legal purposes.

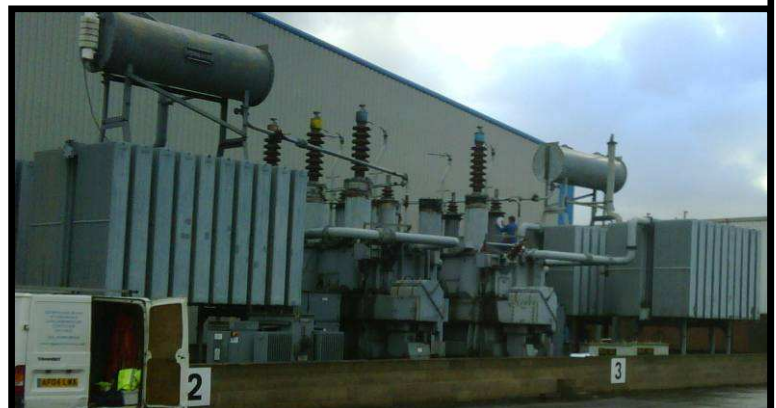
No units could be found that were of the same size as that failed as not many companies hold this size of unit as a strategic spare, however TPPS Ltd found a generation company that had a Ferranti 90 MVA, 132/11kV, OFAN, Yd1 transformer at its central stores within the UK. Although only 90 MVA compared to the 155 MVA that failed, the option was proposed and accepted that it could be updated and re-engineered to a 117 MVA OFAF unit that would allow the power station to generate. The transformer was sanctioned for a series of tests to ensure its integrity, and once approved the unit was procured and dismantled.

As the replacement unit was OFAN cooled the most effective method of uprating was to use cooling fans to force air over the radiators increasing the cooling efficiency of the insulating mineral oil and turn the unit into an OFAF cooled unit. The decision was approved to utilise the cooling fans from the failed unit and support frameworks were designed and fabricated to secure 8 cooling fans under the 16 radiators on each of the 2 cooler banks. Design and interchangeability studies between the failed and replacement unit, and its interface with existing installations, identified critical functions that would also need re-engineering. It was imperative that internal, control and protection components be modified or added in order to accommodate the increased rating. Whilst the ancillary components of the cooling system and tank were being dismantled for transport the following modifications were designed, materials and components procured, and brought back to the company's premises for modification.

- Identify and source Current Transformers to meet the station's protection system
- Procurement and supply of Oil and Winding Temperature Indicators for increased protection
- Re-engineering and replacement of HV line ends to carry the increased Amps
- Modification to LV & HV turrets to allow mounting and installation of additional CT's
- Design, fabrication and mounting of CT connection boxes for termination of new CT's
- Major re-wiring of the marshalling kiosks to include additional control and protection circuits

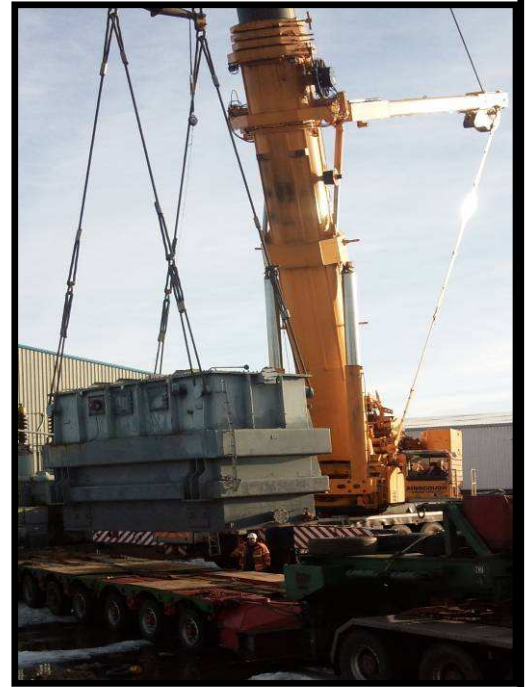
TPPS Ltd were challenged to dismantle the transformer's ancillary equipment and secure them for air freight within 18 days of the replacement unit being procured. The sizes of 17 packing crates for ancillary equipment such as radiators, pipework, control and marshalling kiosks, bushings and the conservator had to be estimated, confirmed by the shipping company, made and delivered whilst the transformer was still being dismantled in order to meet the deadline. Even faced with below freezing temperatures that stopped work, engineers completed the dismantling and packing of the transformers on schedule and TPPS Ltd engineers secured and loaded the crates onto 3 articulated vehicles for transport to Heathrow Airport for commercial air freight to Kuala Lumpur. The 85 tonne mass of the main transformer tank would take 85 days to get to Malaysia by boat, so the Antinov AH-124, the third largest air freight carrier in the world, had only one flight available and was chartered to fly the transformer from East Midlands Airport.

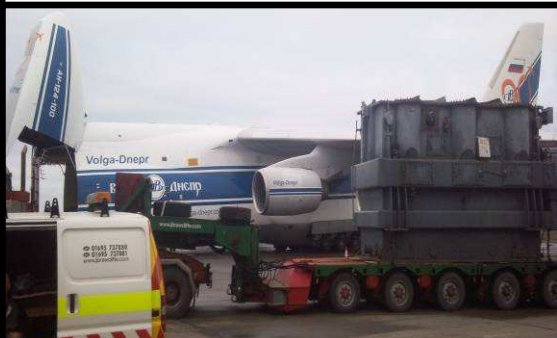
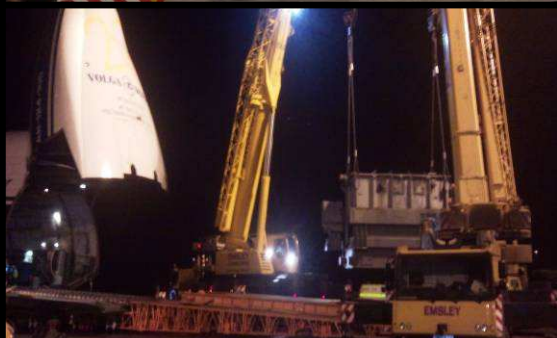
TPPS Ltd sought the services of approved subcontractors to supply a 500 tonne crane to load the 85 tonne main tank onto a heavy haulage low loader the day before the Antinov AH-124 departed. Once loaded the tank was taken to our factory for final modification and testing overnight, before being escorted to the freight area at East Midlands Airport. The tank was loaded onto the Antinov's entry ramp by two 250 tonne cranes, and winched into the centre of the plane with millimetres to spare, along with the crates containing the cooler bank framework. After the 6 hour loading operation the Antinov made 2 refuelling stops over its 60 hour journey to get the transformer to Kuala Lumpur where it was received by the installation contractor. The majority of remaining ancillary equipment for mechanical erection was dispatched in order of installation over the next week on the first available commercial flights.

As part of the contract agreement TPPS Ltd continued to offer technical support to the client and the installation contractor after delivery of the replacement transformer and through the final testing and commissioning stages of the project. The transformer was successfully commissioned and energised to allow the power station to generate once again.
