## ELECTRICAL ENGINEERING SOLUTIONS FOR HIGH VOLTAGE NETWORKS

CONTRACT:	TPPS-14
SCOPE OF WORK:	Isolated Phase Busbar Refurbishment
END CLIENT:	EDF Energy
LOCATION:	Dungeness B Power Station, Kent
DURATION:	11 weeks
VALUE:	£ 204,250 GBP

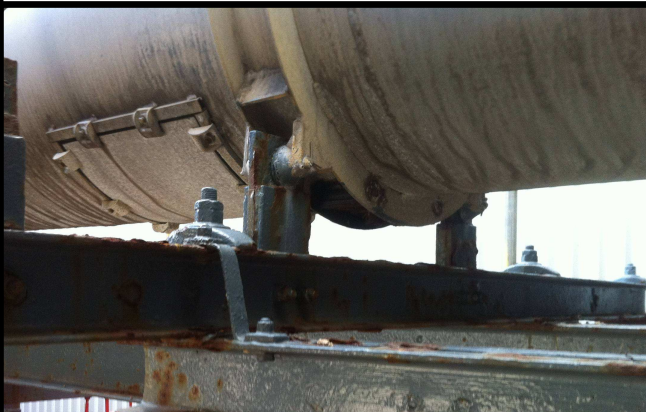
The client requested that each steelwork assembly, expansion bellow or conductor support insulator was given a specific identification code that would clearly identify the assembly type, phase and numerical location within that phase; and gave TPPS Ltd the challenge of designing and implementing an effective QA system as there was no existing system in place. General arrangement and location maps were issued and approved for reference and task specific control documents implemented to record every aspect of the works including the reverse engineering and fabrication of replacement components; all including a variety of inspection, hold, test and witness points for the client to review works completed. The design and implementation of location specific codes proved invaluable for clearly communicating works progress, corrective actions, remedial works and design modifications.

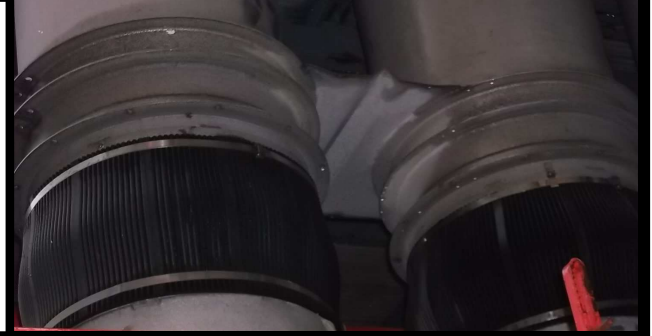
The busbar system operates under a constant pressure by air being purged through to stop the build up of moisture within each phase of the busbar sheathing. Each of the 27 access covers and 15 expansion bellows had to be removed to access to the main conductor supports, and TPPS Ltd had to replace 210 metres of seals on the access covers, and replaced the expansion bellows at the client's request. The conditioning air system itself also needed minor refurbishment with a number of valves, support brackets, glands and tubing replaced, and then the system tested as part of the works.

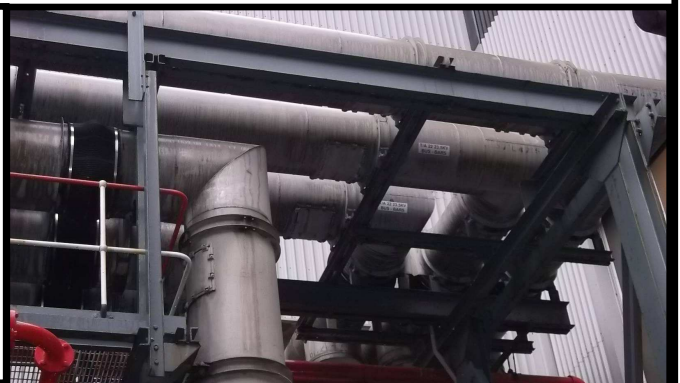
The system needed to be protected against circulating currents between the sheath and the supporting steelwork, meaning that every mechanical assembly needed to be insulated; however material specifications were not available in OEM documents. TPPS Ltd had to identify six different materials to insulate the steelwork, clamps and bush assembly sets, and these had to be passed to EDF's central technical support for approval which delayed supply. Suppliers were put on standby and once materials were approved the components were ordered, cut to size and delivered directly to site within 4 days ready for installation by TPPS engineers.
