CONTRACT: TPPS-08
 SCOPE OF WORK: Transformer & GIS Refurbishment
 END CLIENT: GDF Suez Energy UK
 LOCATION: Teesside Power Station
 DURATION: 34 days over 10 months
 VALUE: £ 148,400 GBP

SUMMARY:

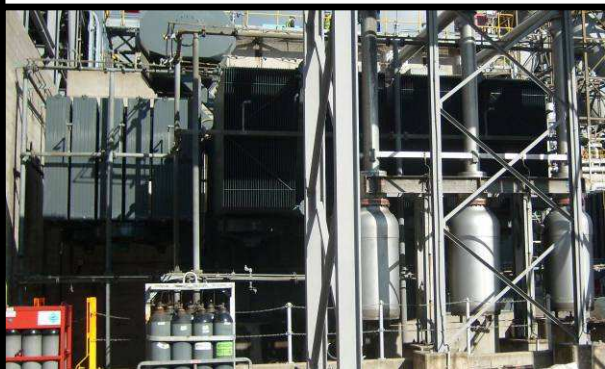
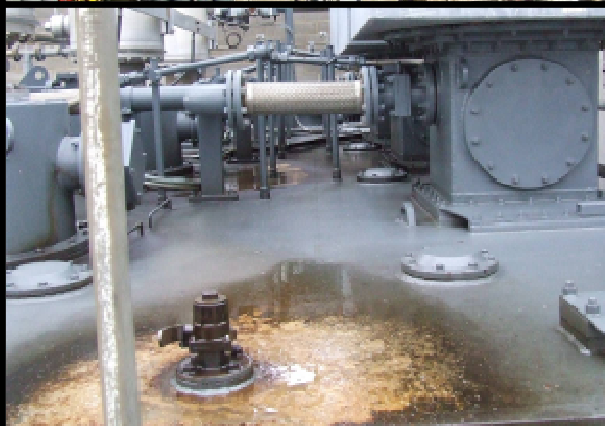
TRANSFORMER SERVICES:

The majority of services delivered on site were to replace components such as pressure release devices, conservator cell membranes and gaskets to cure leaks from the main tanks and required the removal, handling and processing of mineral insulating oil on the 399 MVA generator transformers. TPPS Ltd procured replacement ancillary components from the OEM on behalf of the client to safeguard the integrity of the units for operation and spare components for the site stores. Works also included inspection and testing services as part of the stations five yearly maintenance programme, and included:

- Inspection of mechanical assembly for signs of leaks, degradation & moisture ingress
- Insulation Resistance test of transformer windings and report
- Testing of alarm and trip settings on Buchholz relays, WTI's, OTI's and relays
- Temperature Indicator equipment – Calibration & Current injection tests
- Dissolved Gas Analysis (DGA) of mineral insulating oil and client reports
- Inspection and testing of cooler control for manual, automatic and phase starting
- Maintenance of OLTC and OCTC barrel type tap change equipment
- Inspection and maintenance of marshalling and control kiosks

Works were completed on a total of 6 units at the plant, and delivered most of these on an emergency basis which required mobilisation to site within 72 hours of the works being confirmed by the client.

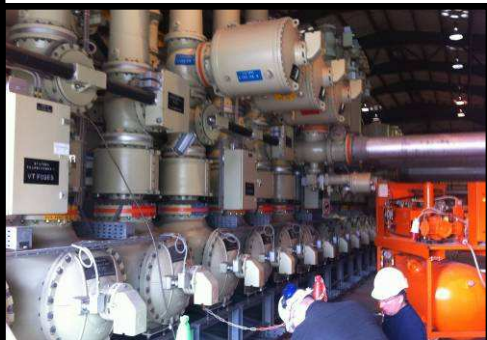
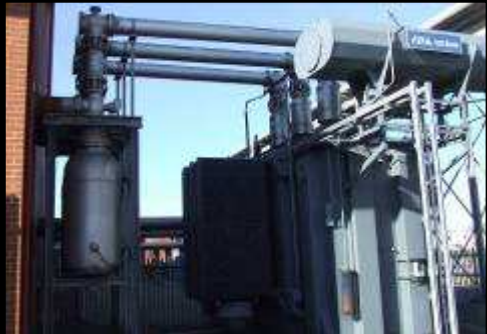
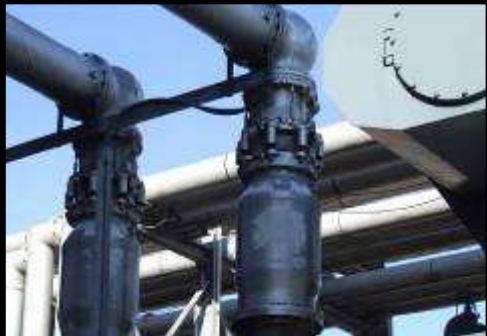
275kV GAS-INSULATED SWITCHGEAR (GIS)

As TPPS Ltd had already been contracted to complete maintenance on the 24 / 36 / 48 MVA, 16 / 11.5 kV station transformer, the client requested we also complete invasive works that would cure gas leaks on one phase of the units connection to the 275 kV GIS, which connected directly to switchgear in the National Grids 275kV Transmission substation. TPPS Ltd was able to complete the works as engineers had previously attended a 3 day training course for safe handling and use of sulphur hexafluoride (SF₆). With only a 6 day window to complete these works, the client requested that the remaining two phases be completed also, and engineers accepted the challenge of completing the extra works in the same timeframe. Each phase of the GIS was split into a number of gas zones and it was essential that any zones adjacent to the one being emptied and dismantled had gas removed to half pressure to avoid rupturing the barrier boards separating each zone due to differences in pressure. Replacement components were procured and delivered directly to site from suppliers, including O-ring gaskets made of EPDM rubber, contact sealant, grease and injection gun for sealing flanged connections and Tor-Wax for coating external flange connections. Although the switchgear was owned by the station, National Grid had operating control of the switchgear as it connected directly to their 275 kV outgoing feed, and TPPS were required to ensure all HSQE documentation was designed and implemented to NG standards for works delivery. The full scope of works included:

- Procurement of replacement EPDM gaskets, contact sealants and greases
- Supply of empty gas container to decant gas for re-use
- Design and implementation of bespoke QA documents to ISO9001:2008

- Preliminary testing of the SF₆ for oxygen, moisture and contaminated gases
- Removal of SF₆ gas using DILO gas cart and flow monitoring equipment
- Dismantle of the connector cover to expose main conductors and completion disconnection

- Dismantle of the main connector and replacement of multiple gaskets per phase
- Cleaning of all surfaces on the main connector using isopropyl alcohol

- Re-connection of main busbar and Ductor testing to ensure integrity
- Application of sealants on all gaskets, and greases to flange connections via injection nipples

- All fixings checked with OEM torque settings and witnessed by the client
- Reassembly of the connector set and application of external sealants and Tor-Wax

- Pressure testing of dismantled gas zones with Nitrogen to check for leaks
- Re-filling of gas zones using recycled gas following approval of integrity tests

- Topping up of gas zones with new gas to replace that lost through original leaks
- Use of gas detection equipment to inspect for leaks and ensure integrity of the remedial works

- Final testing of the SF₆ to ensure oxygen content and dew point are suitable for operation
- Review and transmittal of all recycled and new SF₆ gas handled as per legal requirements

The system was commissioned and energised in line with clients outage programme, and follow-up surveys by the client have confirmed the system has no recurring leaks and is still sealed to this day. Completion of this work proved TPPS's commitment to delivering quality services and constantly developing our service portfolio with of works completed on gas-insulated switchgear.
