ELECTRICAL ENGINEERING SOLUTIONS FOR HIGH VOLTAGE NETWORKS

CONTRACT:	TPPS-06
SCOPE OF WORK:	Rewind of 37.5 MVA Power Transformer
END CLIENT:	Corus UK c/o Quartzelec Ltd
LOCATION:	TPPS Factory, Rugby
DURATION:	6 weeks
VALUE:	£ 168,200 GBP

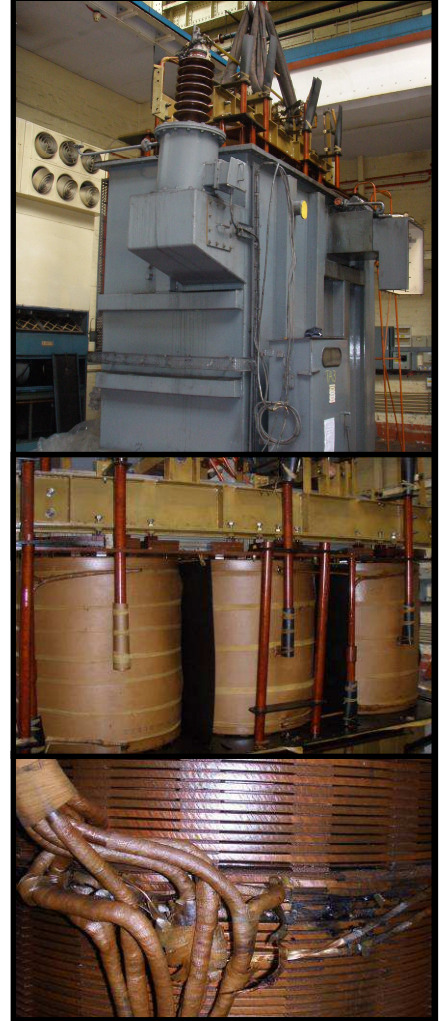
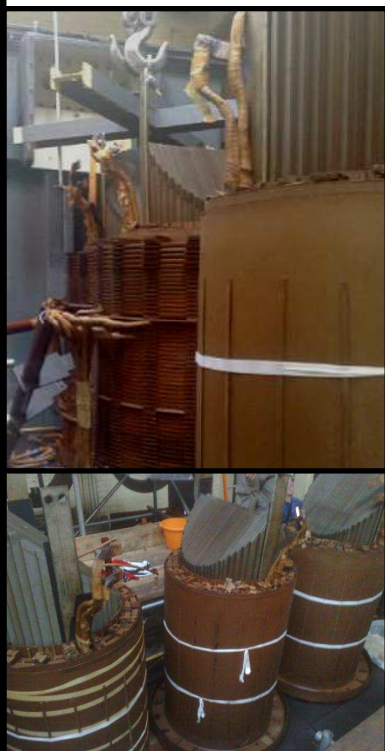
The initial scope of works was to complete a failure analysis of the transformer requiring removal of the mineral oil and tank lid to de-tank the core and windings for visual inspection and testing if deemed necessary. It was evident without testing that a fault on the C phase had caused a number of high voltage turns to explode, and further studies would conclude that this may have been caused through constant operation at its highest tap setting to meet supply at site resulting in a short circuit failure. The client agreed that a rewind option was more cost efficient and quicker than a new transformer in any case, and the fact that LV windings and core were in an operational condition meant that only the three HV windings needed replacing.

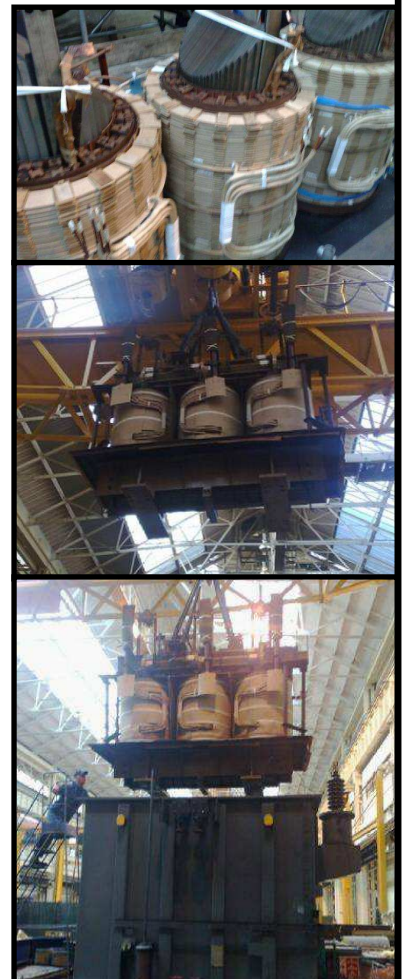
The 23 tonne core and winding assembly was removed from the oven using overhead craneage following the final drying stage and then underwent final inspection to check all connections, terminations and insulation. The assembly was then lowered into the refurbished transformer tank, LV busbars terminated to the bushings within the cable box, the tank lid was lifted into position, secured, and the HV bushings installed and connected to the new HV line ends. A road tanker then delivered and pumped 14,500 litres of mineral oil to BS 148 into the main tank, and the unit was moved to the test bay for final testing to BS EN 60076. Integrity tests included:

Test results confirmed immediately that the unit met the industry standards for operation, and the unit loaded and transported back to site for installation two days later. Final reports would be issued to the end client within three working days to support final commissioning and energisation of the unit at site.
